# ANDREW MORRISON INDIAN HERITAGE MURALS

## Progress Report 2

January, 2015

Prepared by Andrew Morrison and  
Jones & Jones Architects + Landscape Architects + Planners

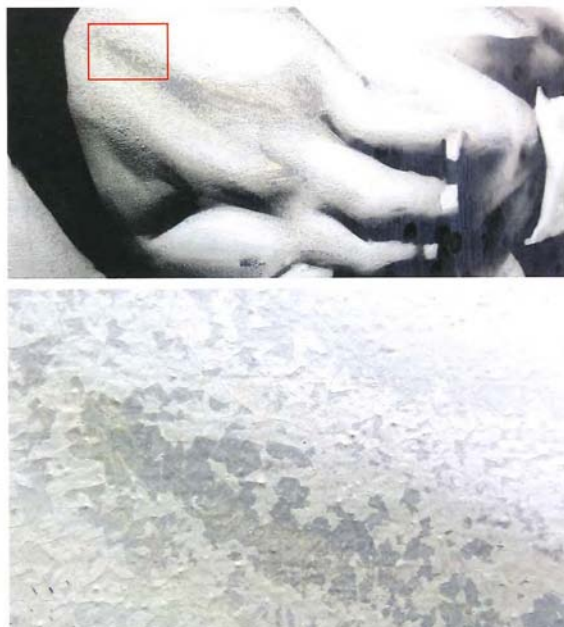
**Mural 1** is exhibiting the most critical and active deterioration in the applied mural paint layers of all the murals. There is widespread, paint layer-specific micro-flaking and powdering of two white paint layers and deterioration of the coating.

Figure 1.5 shows micor-flaking that is occurring throughout the Chief Sealath mural. The micro-flaking is occurring in a muted-white color below a cold-white layer that is powdering. The deterioration appears to be active and is affecting much of the white paint layer in the robes, hands, face and background.

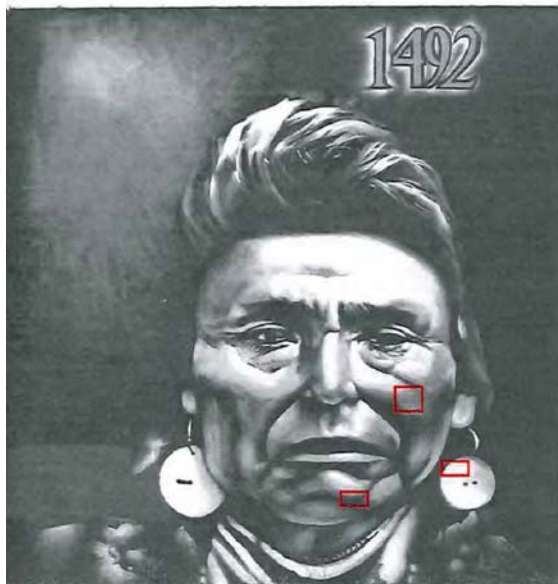
Figure 2.4 shows damage to the concrete support resulting in loss and delamination of the paint layers. This will need to be stabilized prior to transfer.

Figure 2.5 shows delamination forming in the pre-existing paint layers. Edges of an area of historic paint loss that has been covered by the mural paint layer is pulling away from the wall.

Abrasion causing damage and delamination of the paint layers can be seen in figure 2.6. This demonstrates that ease of access can lead to damage and deterioration of the paint layer.

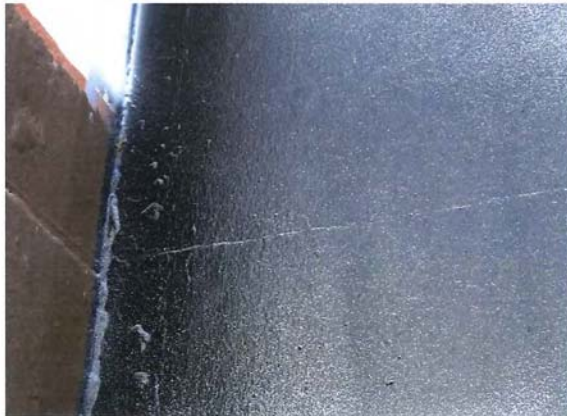
Figure 3.2 shows a horizontal cement seam about 10 ft up, which joins with a seam in the pillar.

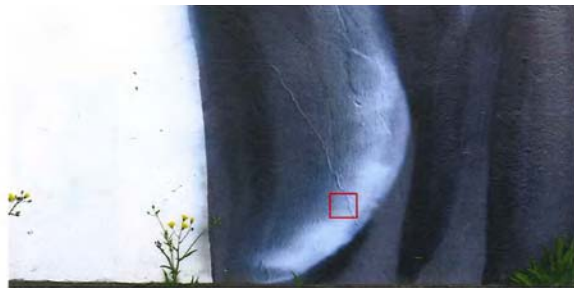
Figure 3.3

A crack in the support is shown above in figure 3.3. The paint layer seems well adhered to the crack, suggesting the was like that when the mural was painted last year, though, cracking of the paint layer itself is beginning to show (see detail).

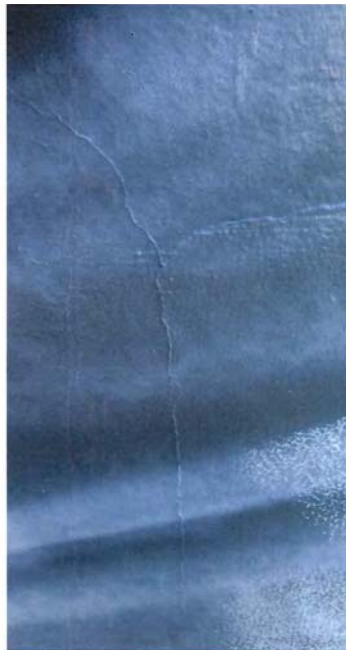
Figure 4.1 shows the upper right corner of the rectangular concrete seam in the center of the wall. A diagonal crack is splintering off from either corner.

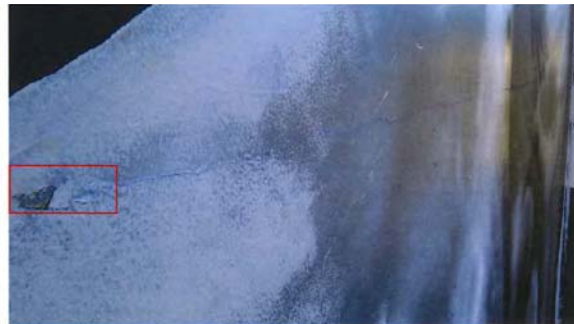
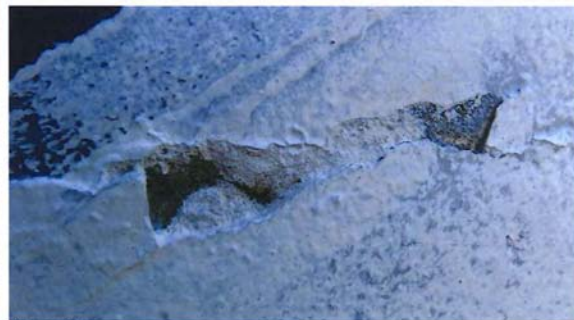
Figure 4.2 shows cracks and chips forming along the horizontal seam. The mural was painted in 2013 and there are chipped areas void of paint suggesting that the seam is actively chipping.

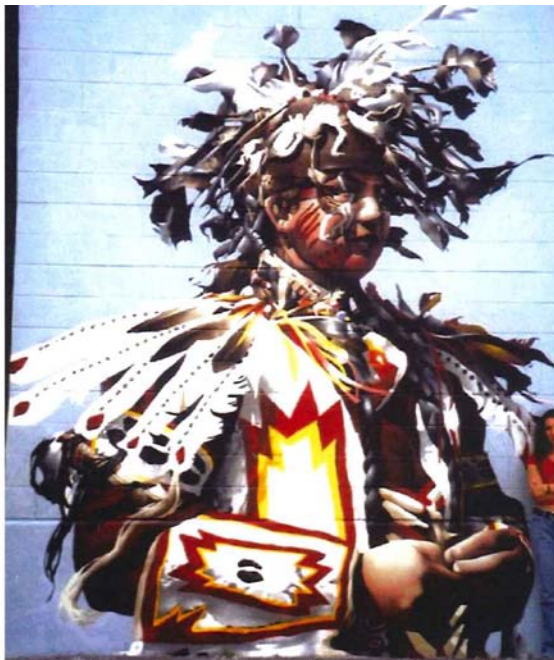
Figure 7.1. Image of mural 7 from just after completion in 2001 (image provided by Andrew Morrison)

Extensive powdering has made the colors appear less intense, which can be seen in comparative images of the mural just after completion in 2001 and in June 2014, though the images were taken in different lighting with different cameras, dulling of the paint and contrasts is quite evident. Whole areas of the white have been washed away in some of the feathers (see figure 7.3).

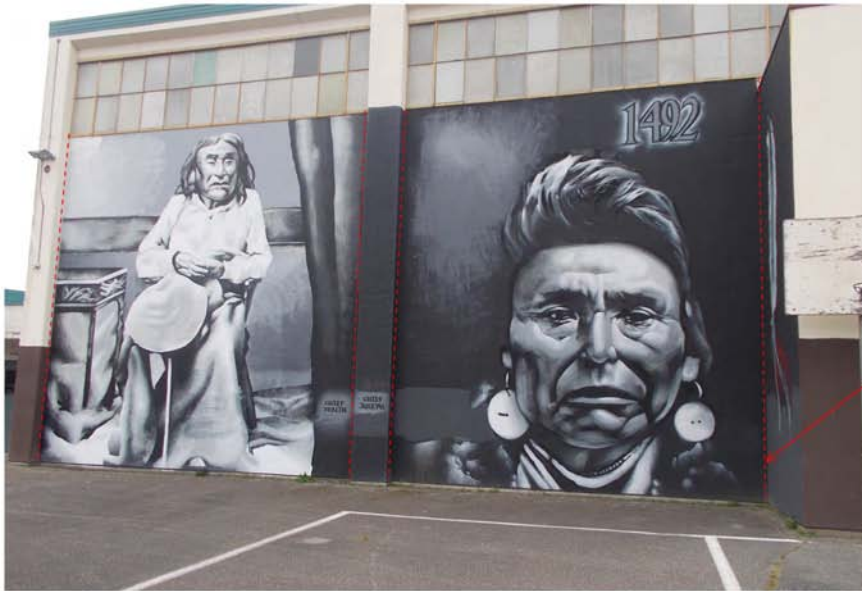
### Mural 1 and 2:

Estimated Weight: 91,000 pounds (each)

Construction: 10" Concrete Tilt-up

Estimated saw-cut line  
locations to be confirmed  
with contractor and  
architect

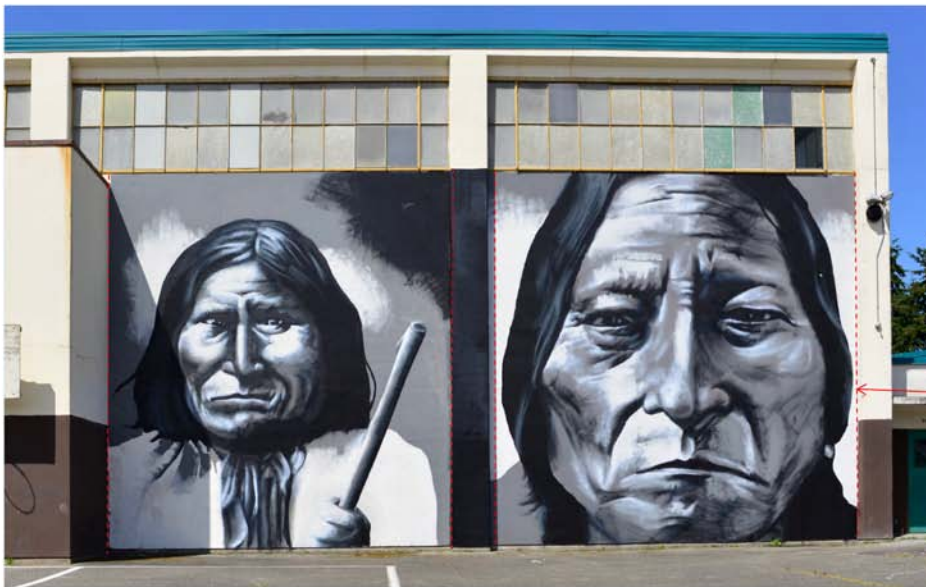
Estimated Weight: 91,000 pounds (each)

Construction: 10" Concrete Tilt-up

Estimated saw-cut line  
locations to be confirmed  
with contractor and  
architect

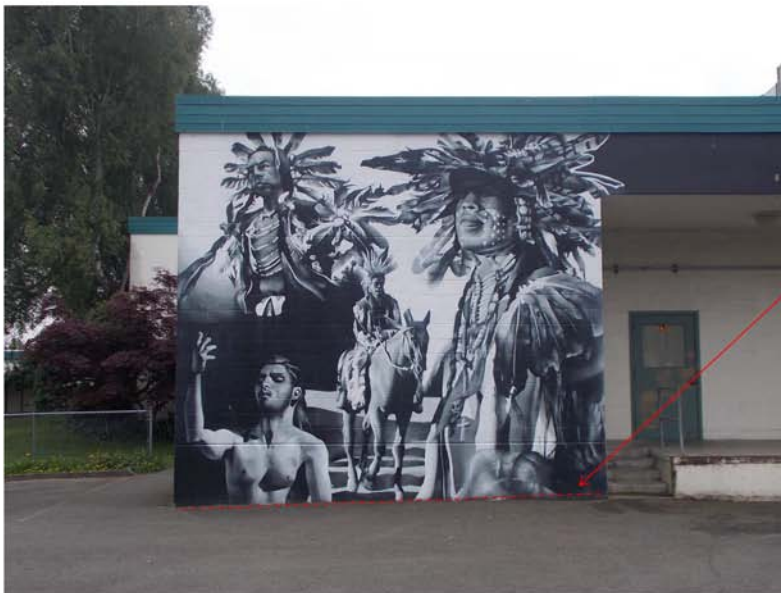
**Mural 5:**

Estimated Weight: ~25,000 pound

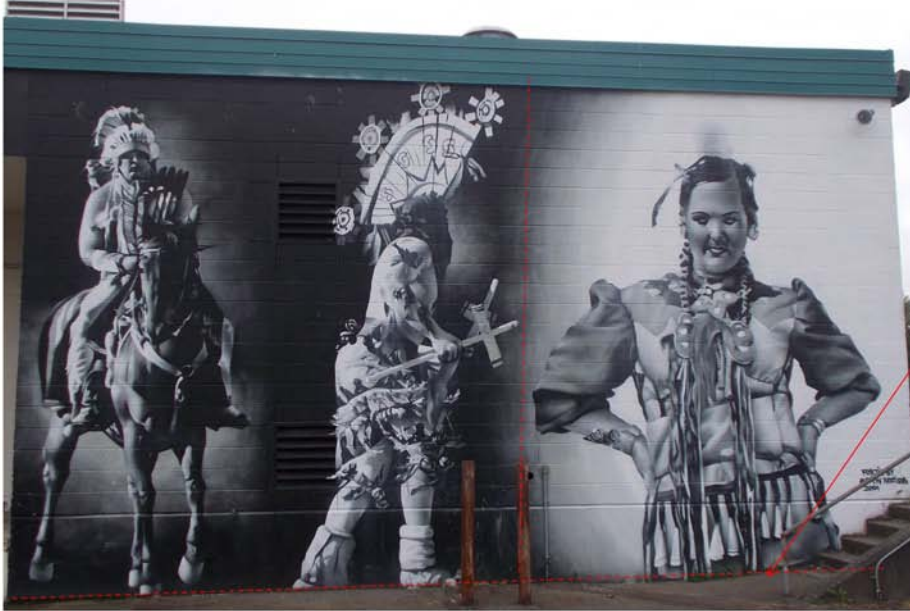
### Mural 6:

Estimated Weight: ~60,000 pounds total

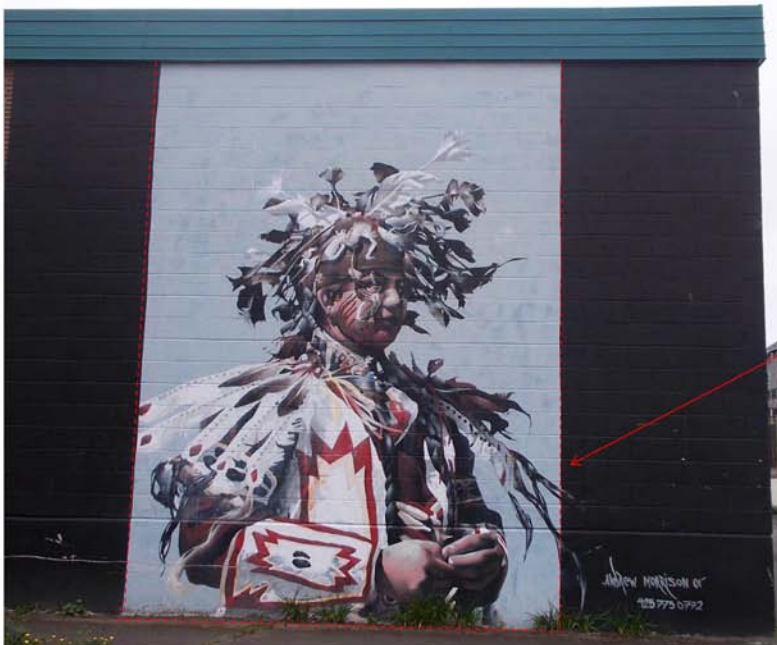
### Mural 7:

Estimated Weight: 20,000 pounds

Estimated saw-cut line  
locations to be confirmed  
with contractor and  
architect

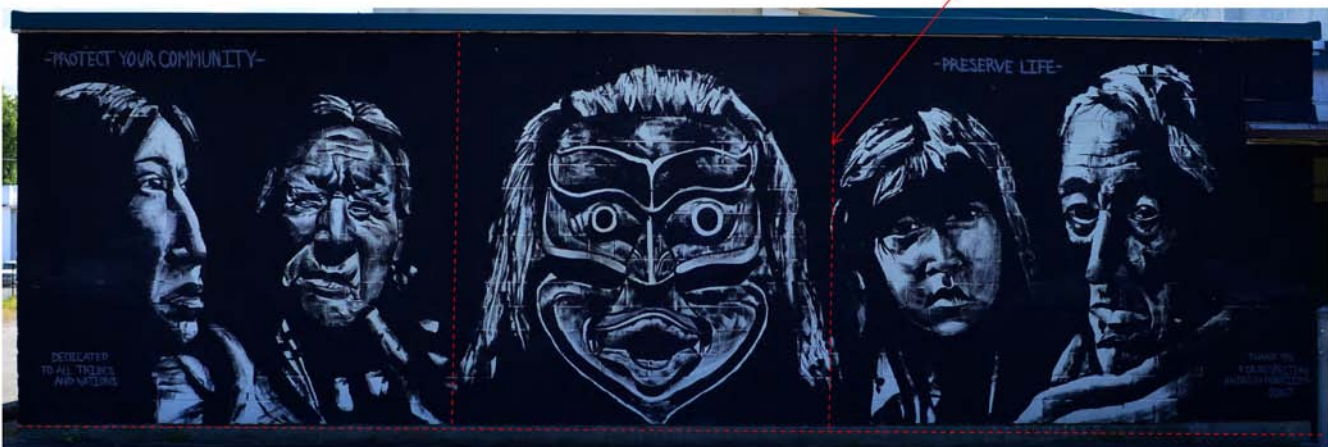
Construction: 8" CMU Partially Grouted

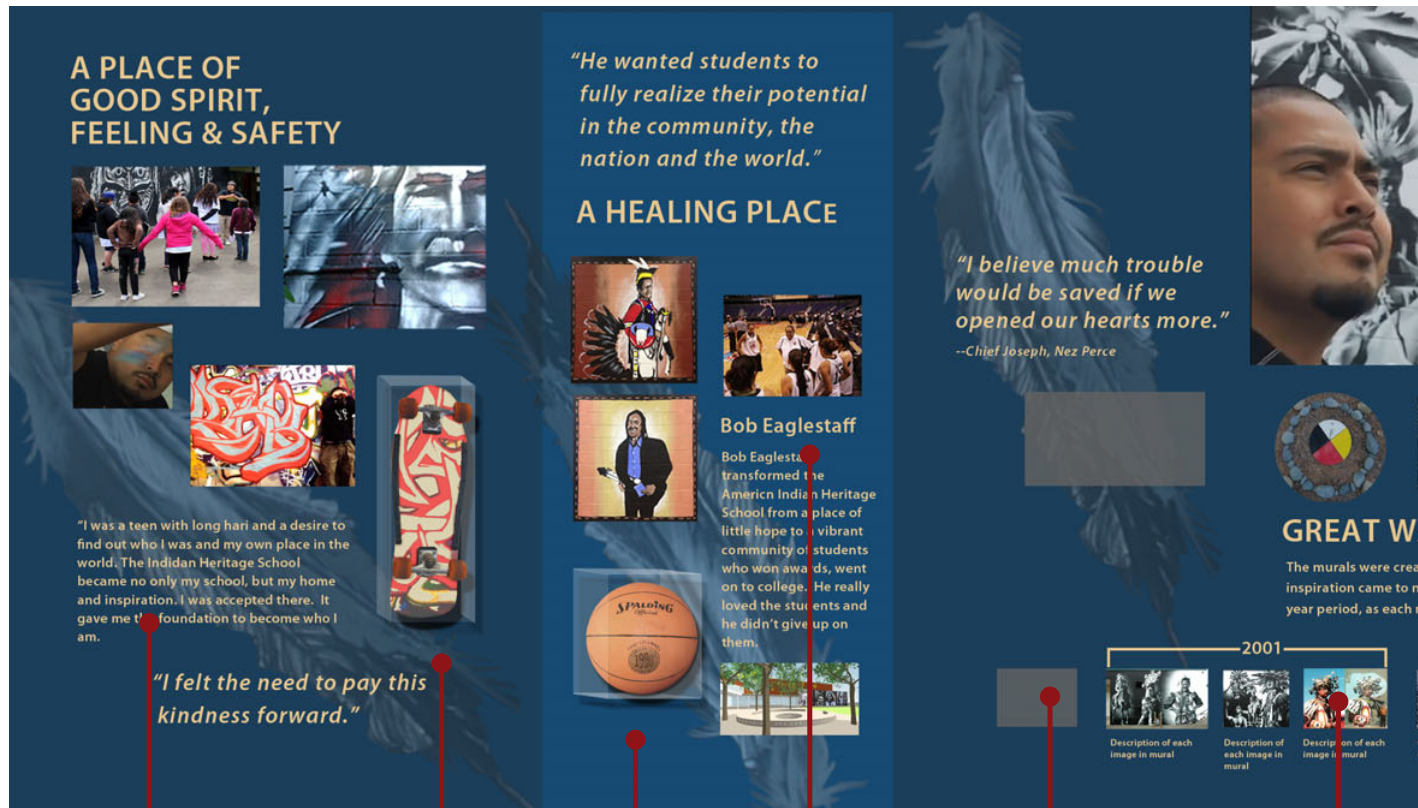
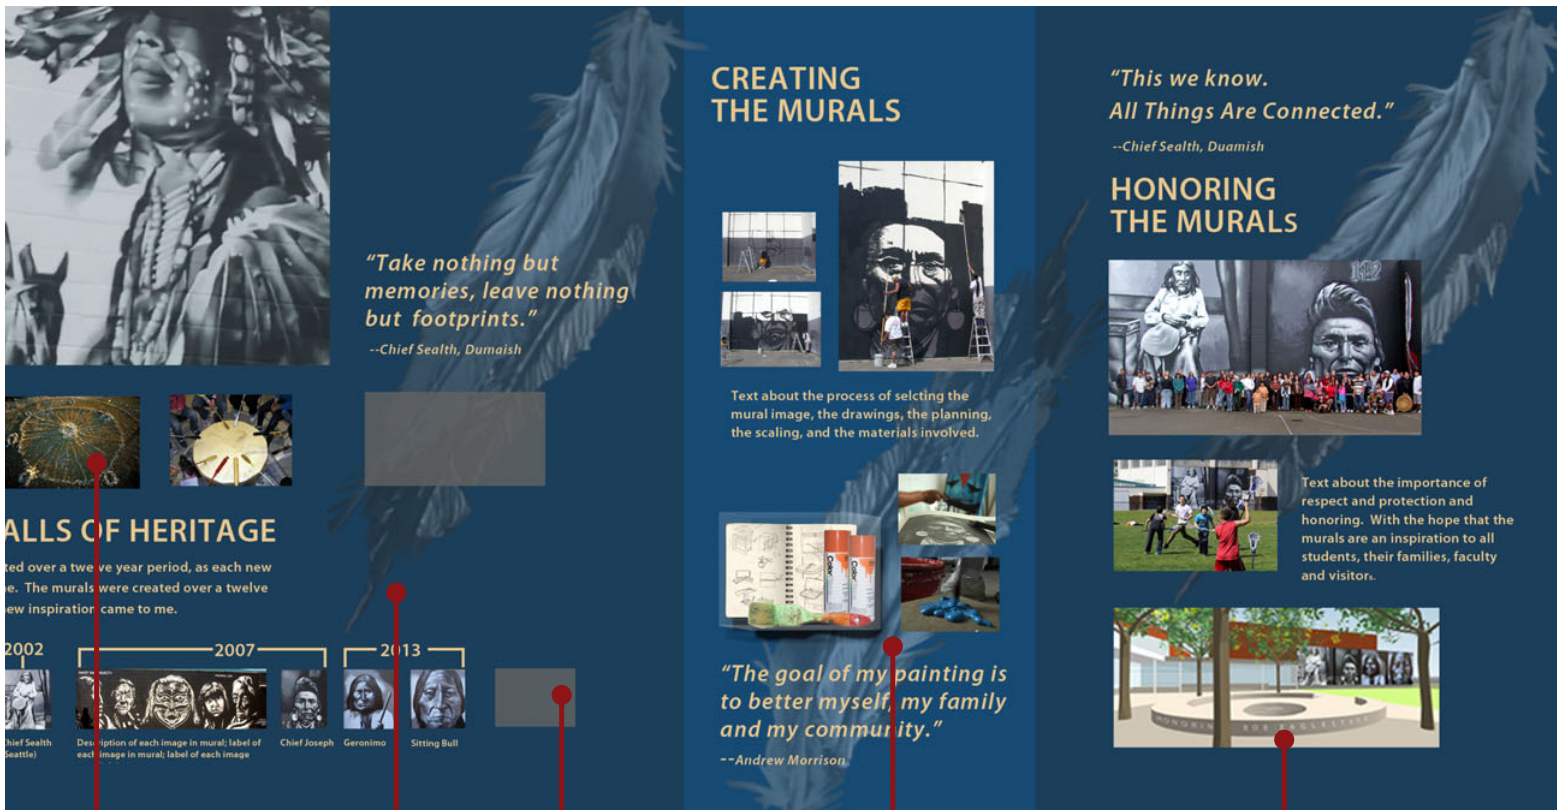
# Rough Concept for Interpretive Wall

The intention is to simplify all text for appropriate ways of telling the story to the age groups of each school

3D "memorabilia" object in plexiglass box

Story of the  
Licton Springs  
and red mud  
to be included

Interactive LCD  
with photos and  
info on the  
history of the  
school, the chiefs  
and other mural  
subjects, etc.
